## Hazardous leakage

## A single integrated component

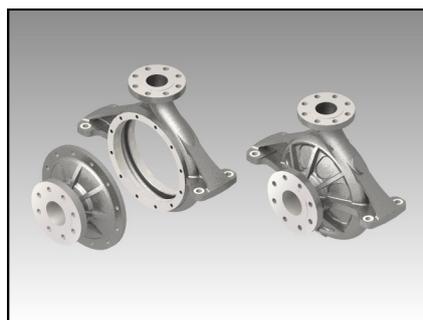
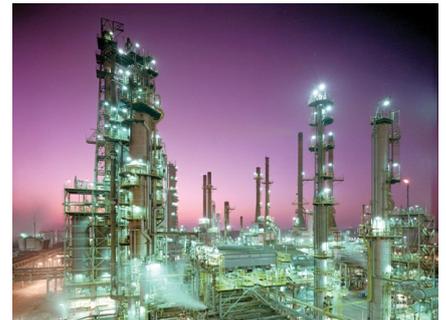
Amarinth proposed a single integrated component consisting of the volute and the suction cover. This was designed to be dimensionally interchangeable with the original components so that no modifications were needed to the pump or the pipework. This new component was up-rated from 16 bar to 20 bar in order to match the rating of the flange and was radiographed and die penetrant tested.

Since fitting the new component there have been no further problems. BP has benefited from a re-engineered component that actually costs less than the equivalent pair of OEM parts, has reduced unplanned maintenance and prevented any further unforeseen leakages. The life of its expensive exotic alloy pump has been significantly extended.
